Title:	On Issues with the Gate End Switch			ID:
				0289
Date in:	Response:	Model:	Author:	
2007-06-06	2007-06-06	STX40	CMa

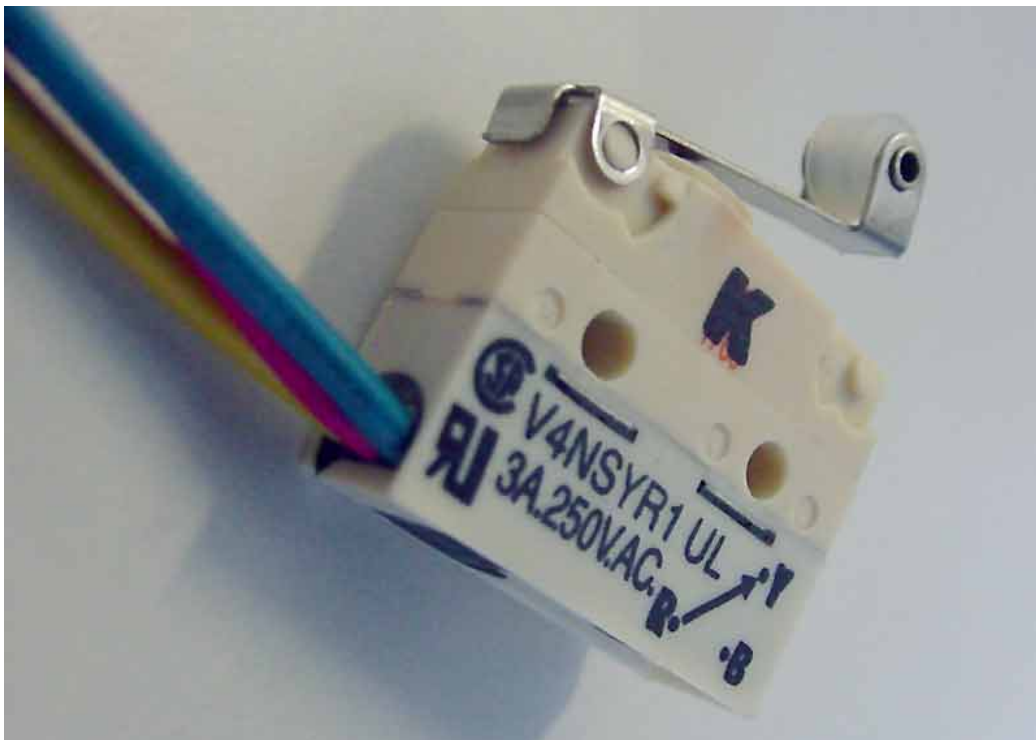
Finally, the problem which I have reported in March was detected again on STX40 (S/N: 1316) and I could get its error code with "RD DM200". The response was 09991. The ErrConv2.exe told that the upper gate open switch didn't detect the gate in time (error 7).

We observed some issues with these switches in the recent past and we think it has to do with the soldering of the wires to the switch. The number of issues increased after switching to led-free solder. Note the Pb-free solder has even higher melting point. When you replace the Gate Switches make sure that you use the new style switches with the cables attached.
